**PCB Hot Spot Area TCRA
Project Status Update
BCT Meeting July 28, 2011**

Acceptance Sampling, RSY Pad – July 13, 2011

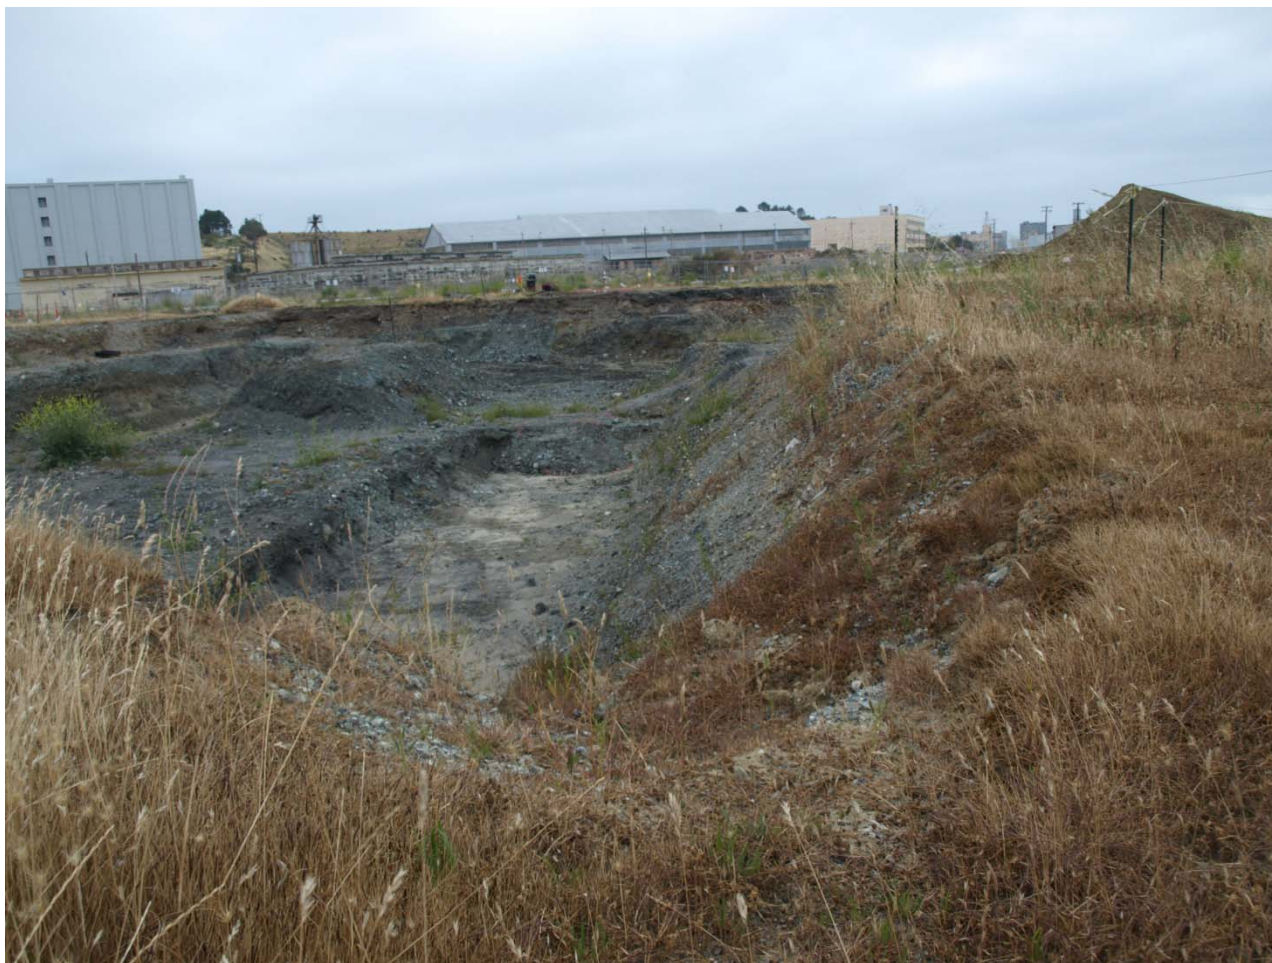
Tiers 3 and 5 Looking East – June 8, 2011

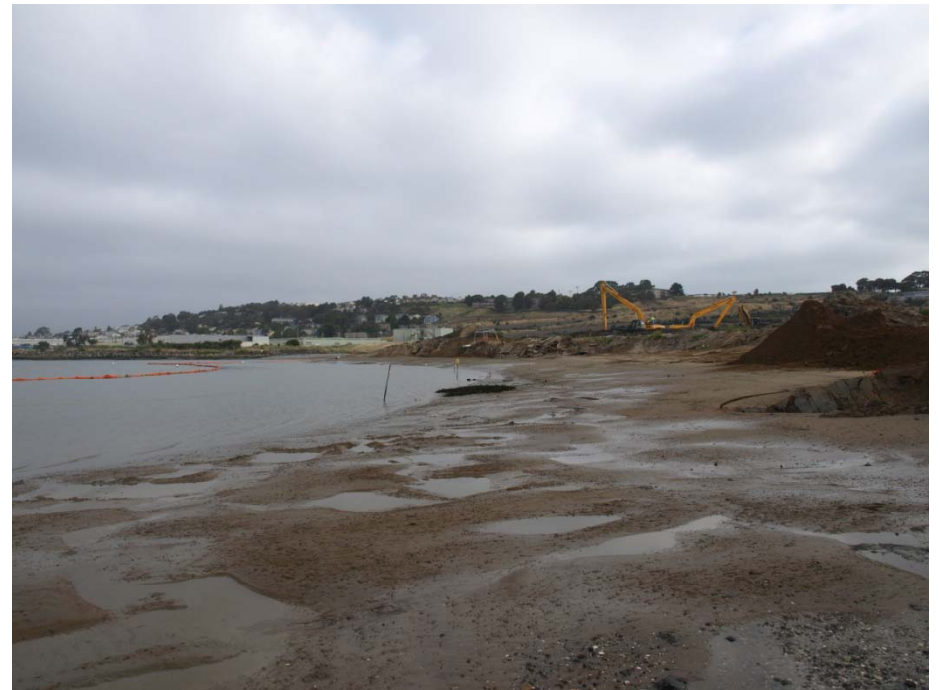
View of Tier 1, looking northwest

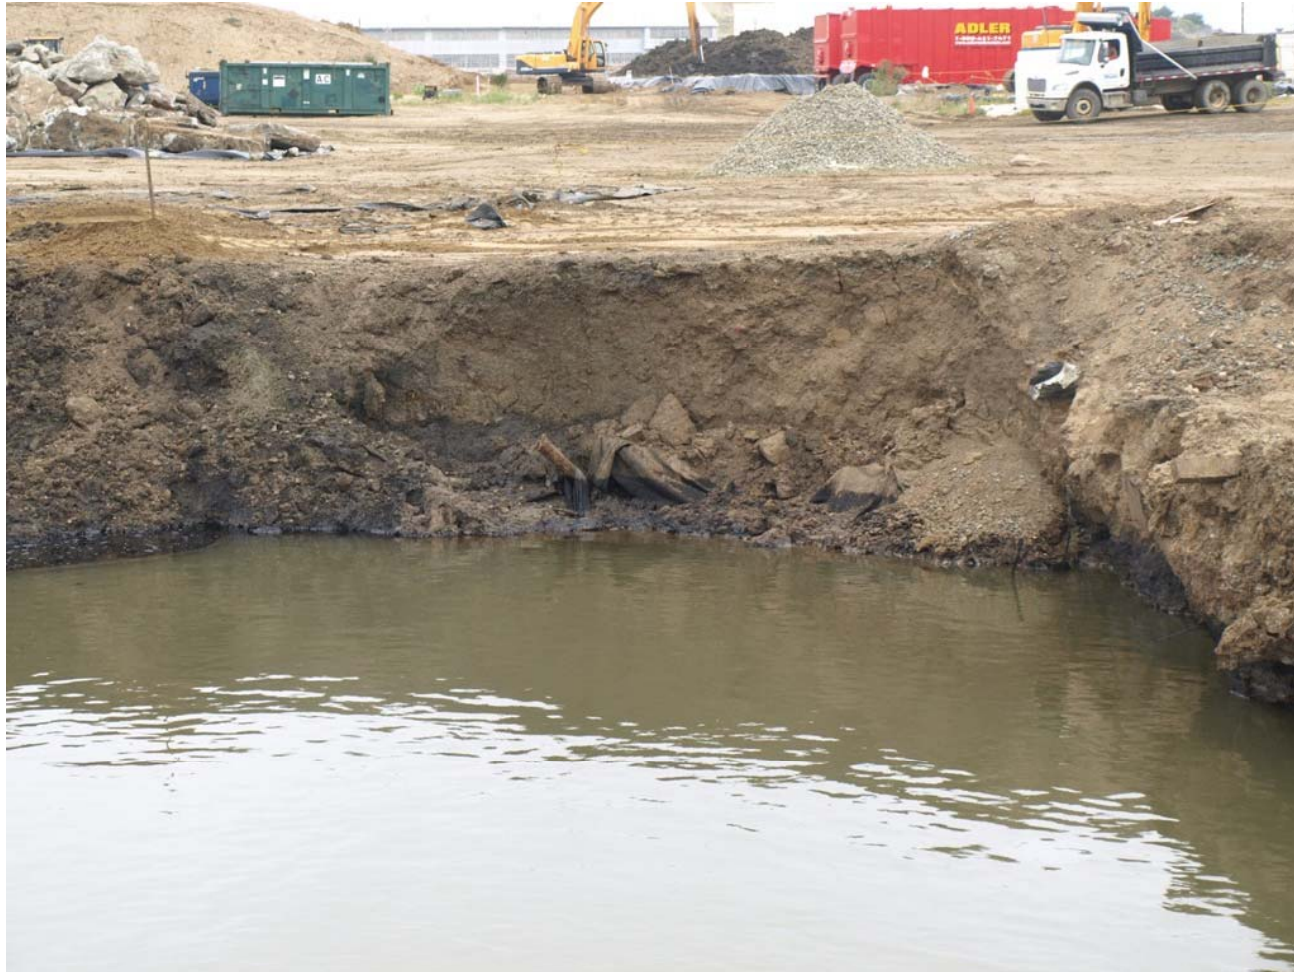
Geofabric from first TCRA visible in sidewall of Grid 150 – July 13, 2011

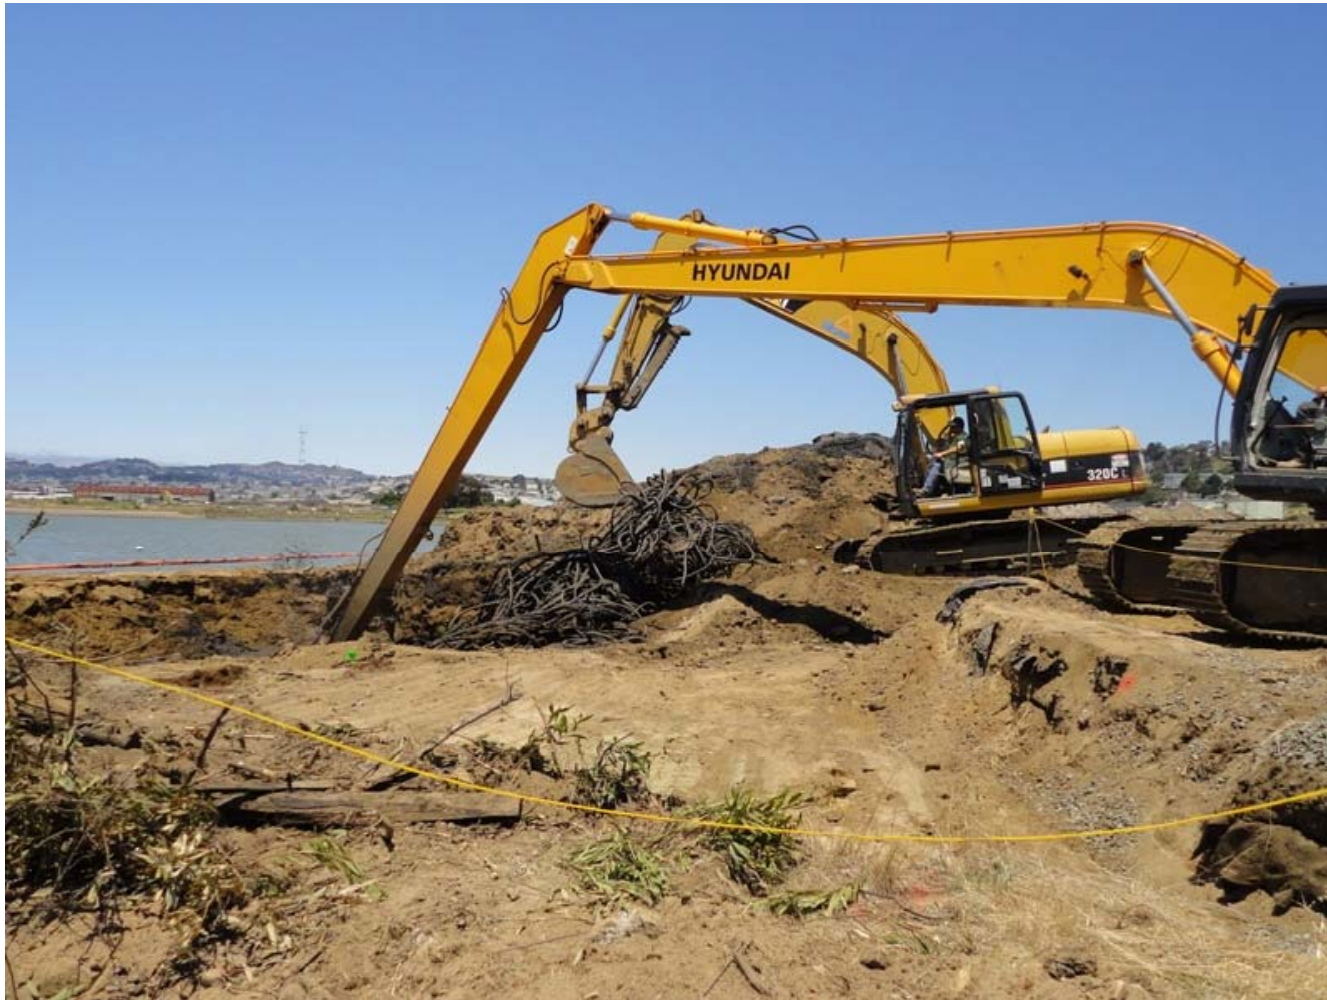
Removing cables from Grid 150 – July 6, 2011

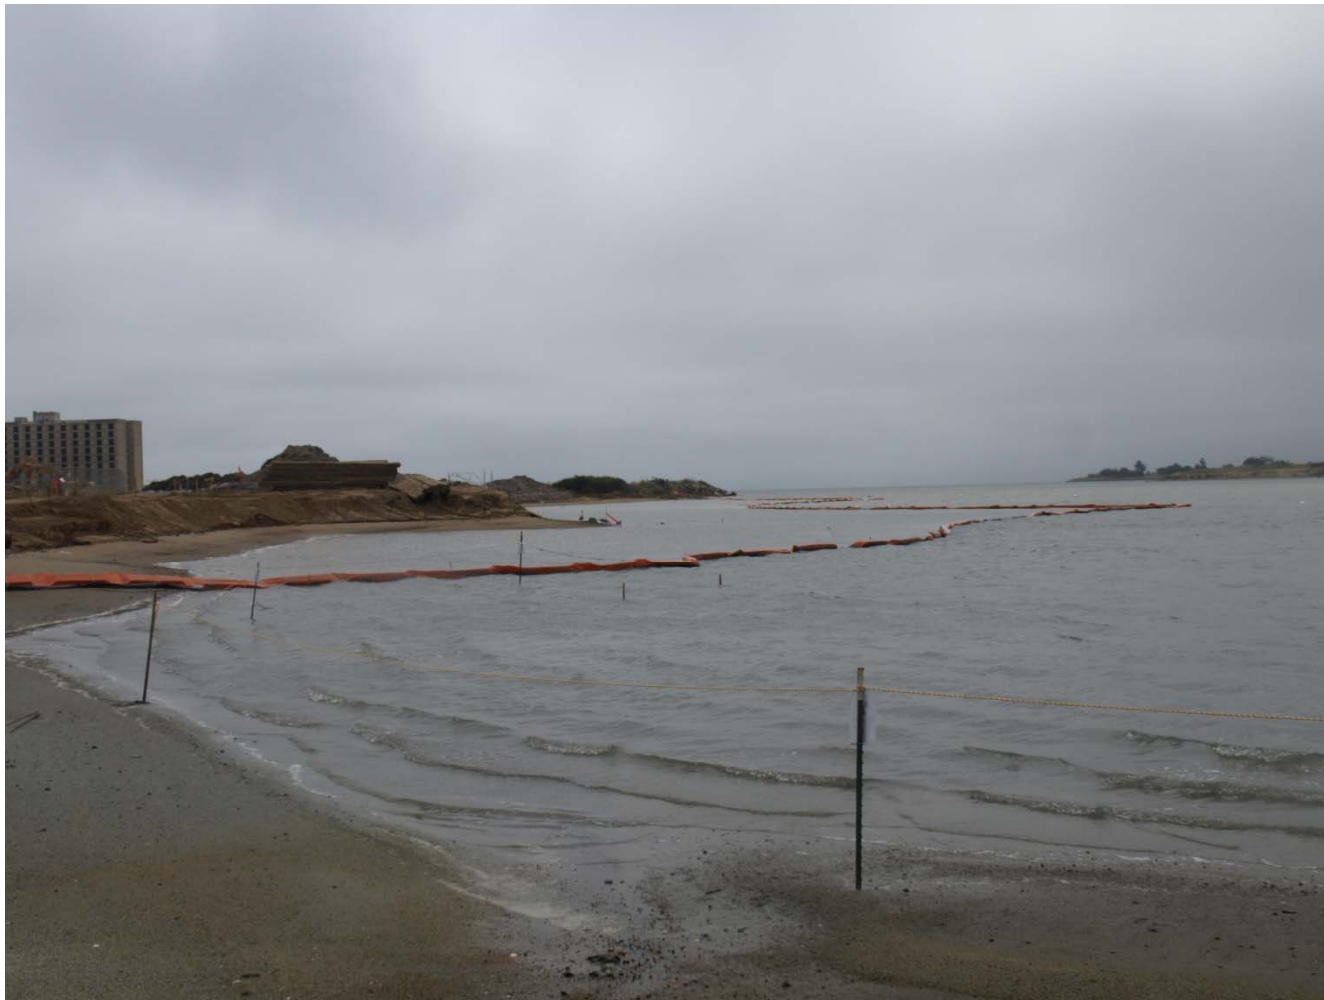
View of Tier 1 from Tier 2 – July 13, 2011

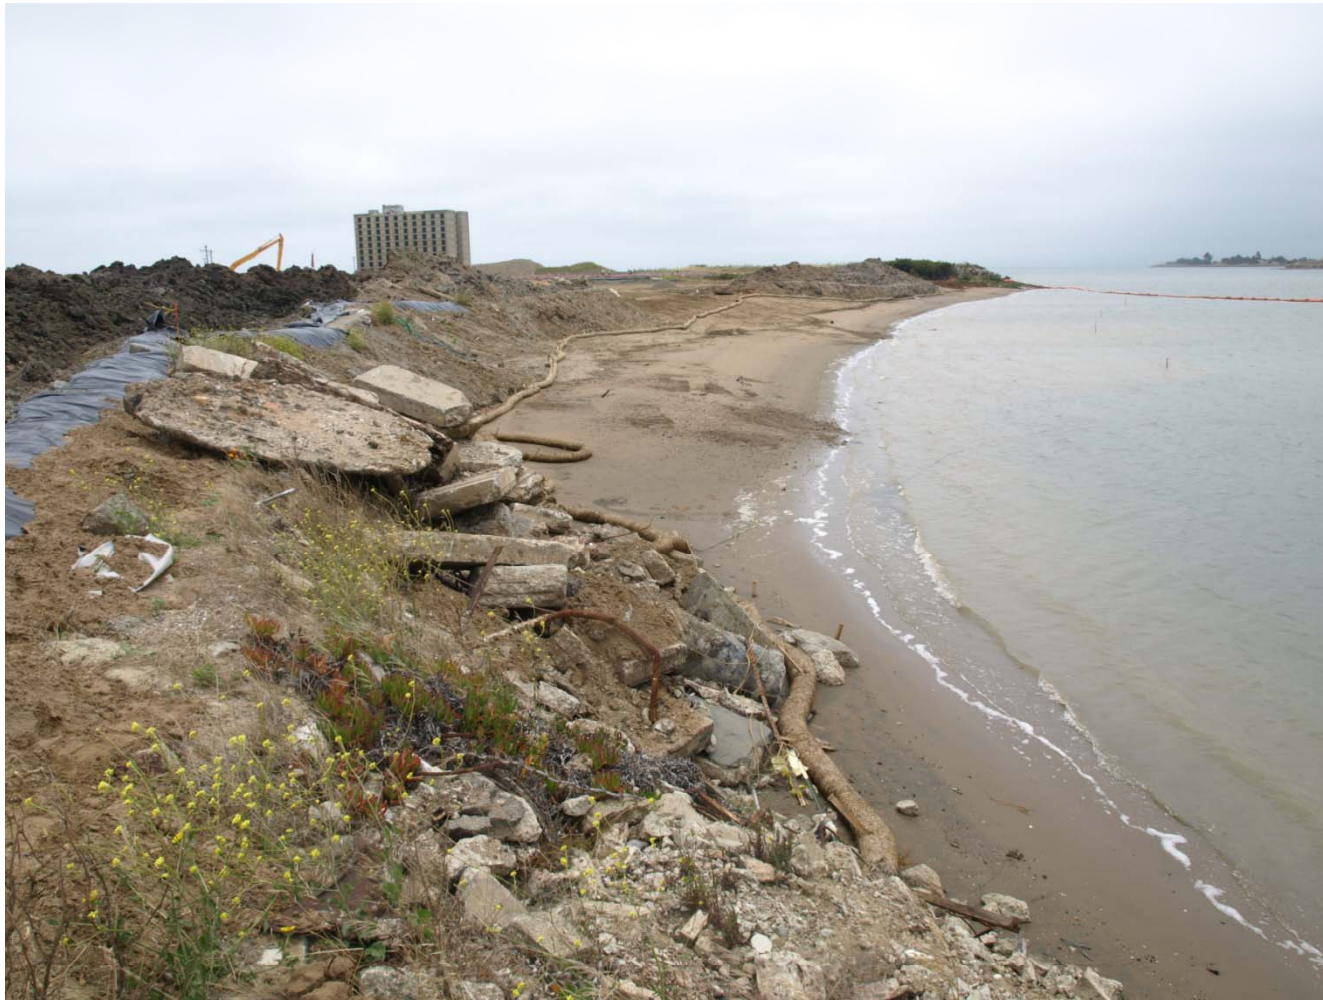
Shoreline and drying cells located in areas to be excavated – July 13, 2011

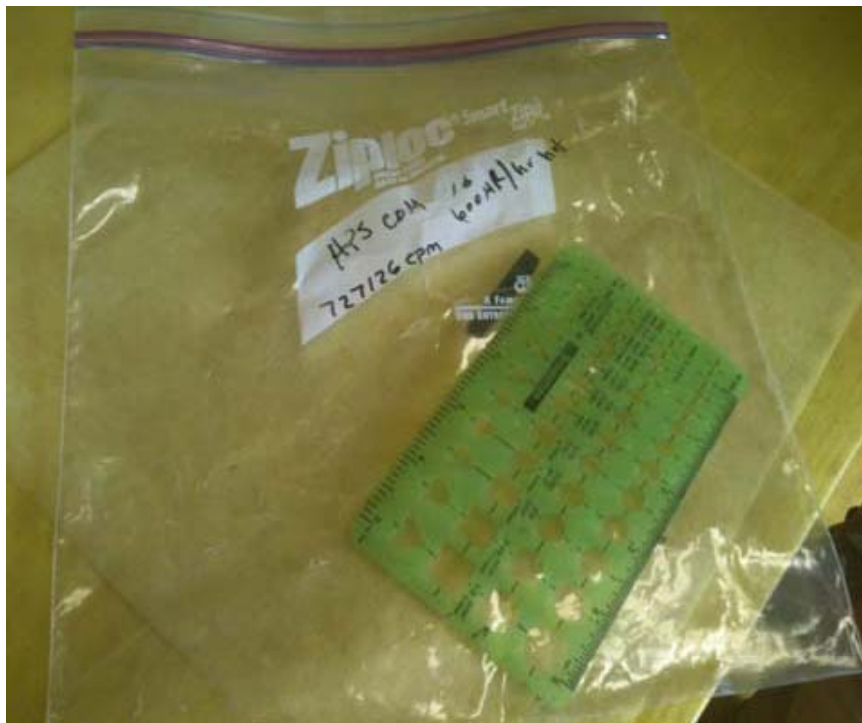
HPS-COM-016, Metal Strip

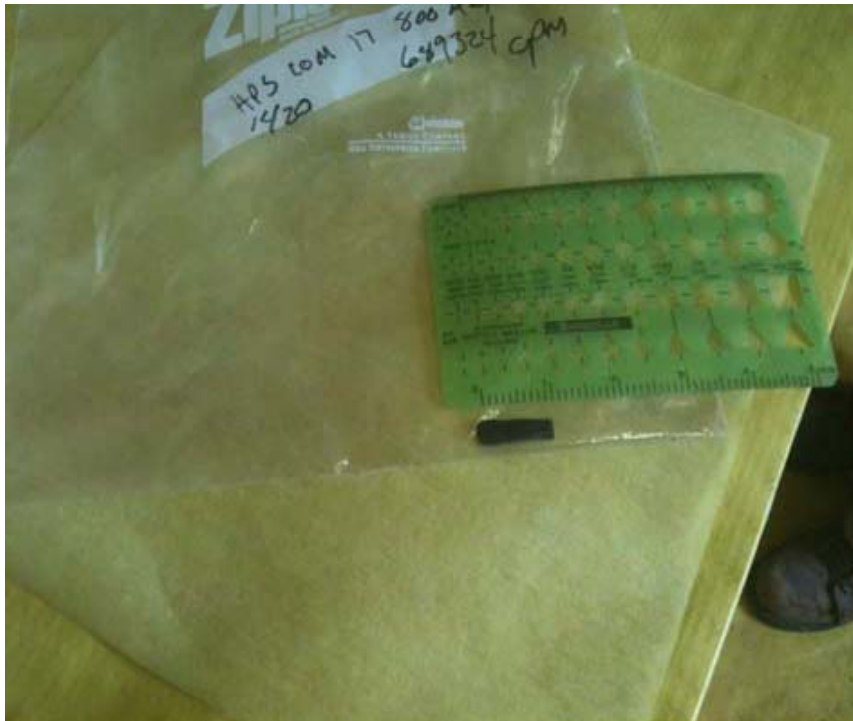
HPS-COM-017, Metal Strip

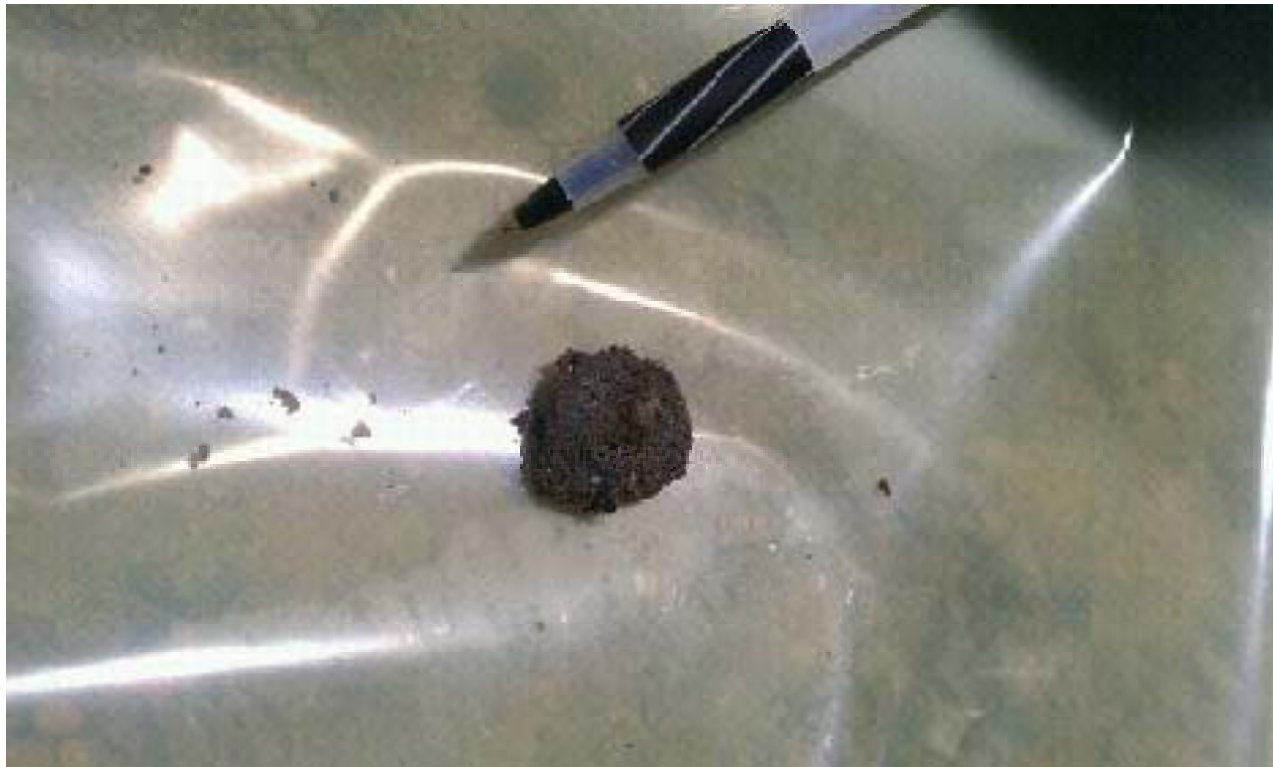
Radiological Commodity

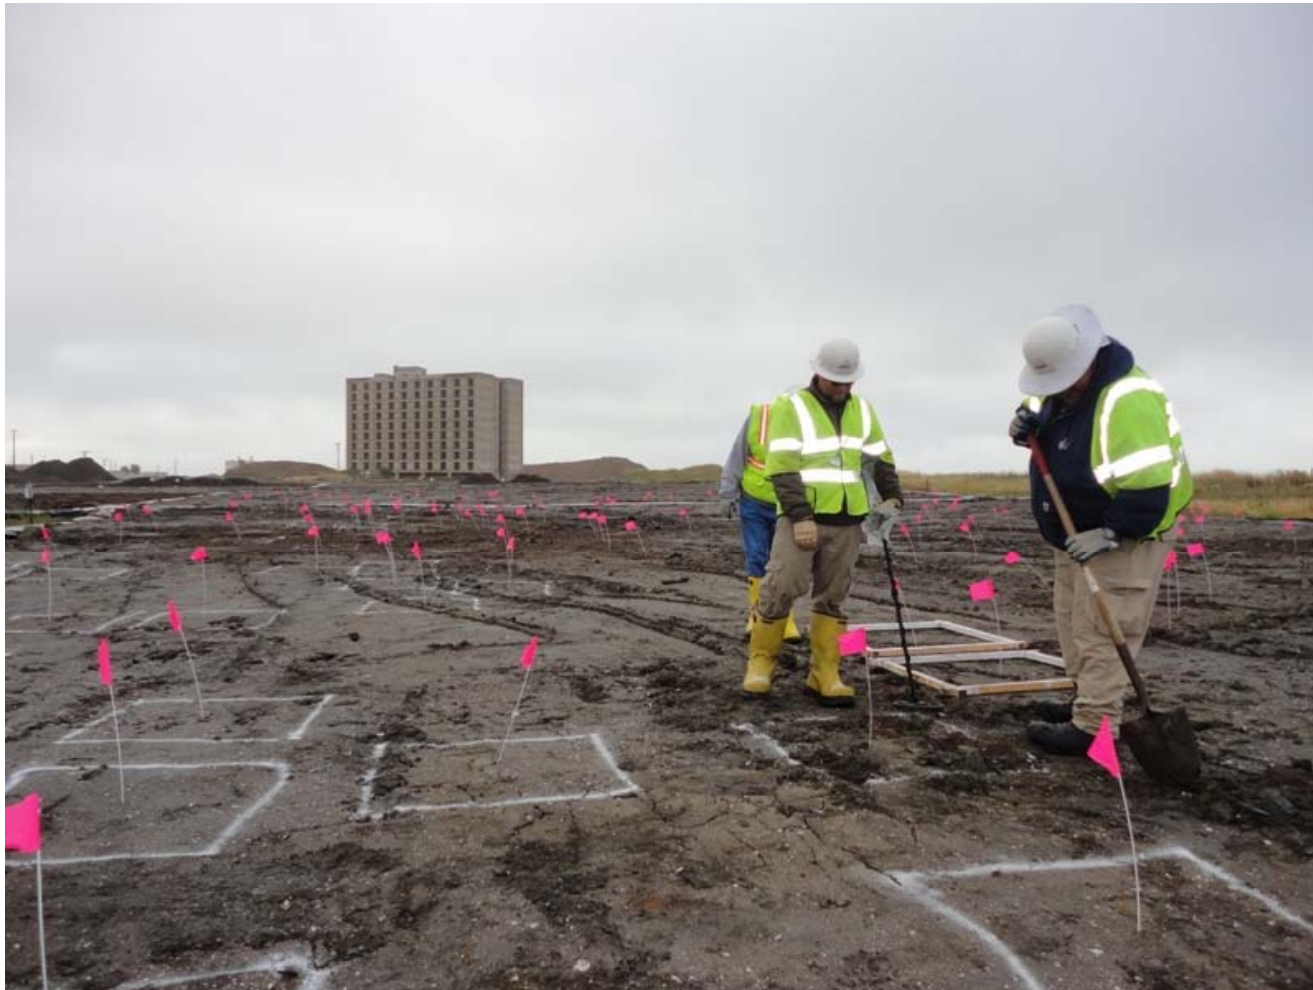
Pad with flagged 3-foot x 3-foot grid cells – July 13, 2011

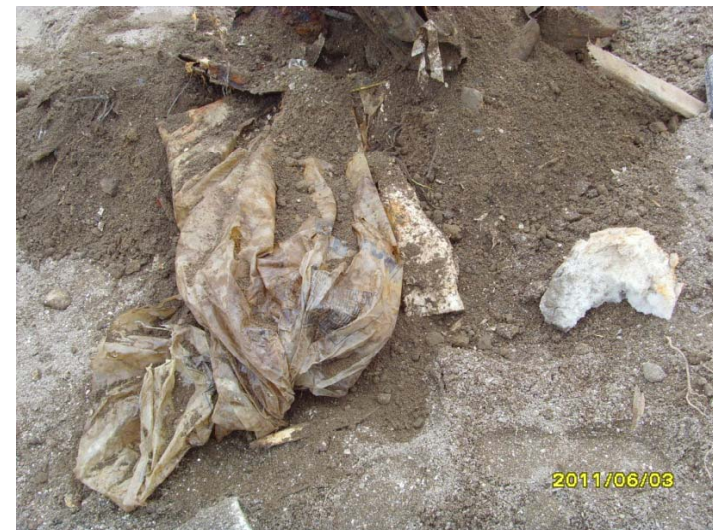
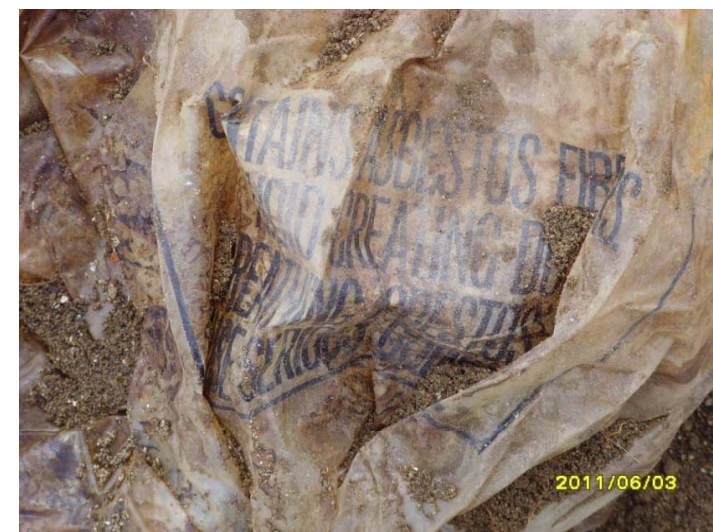
- Two bags marked asbestos with asbestos-looking material were encountered in Tier 1, grid 161 (quadrant B), at approximately 5 ft bgs
- Area was sprayed down to wet the bags and surrounding soil, then remotely loaded in a double-lined LLRW roll-off bin
- Two samples were collected
- Asbestos **not detected**

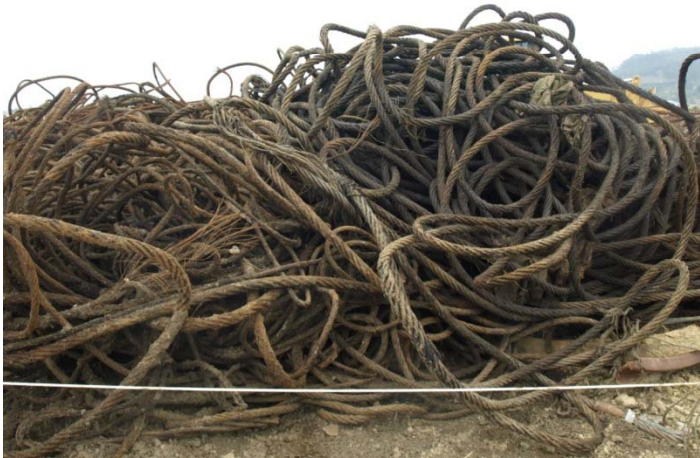
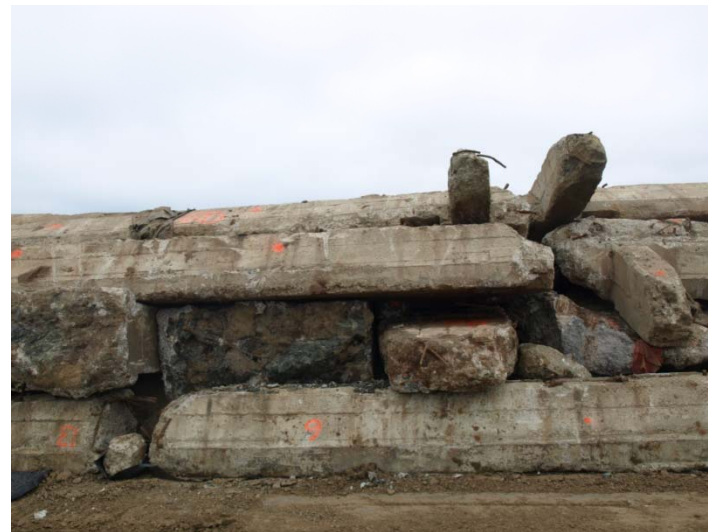
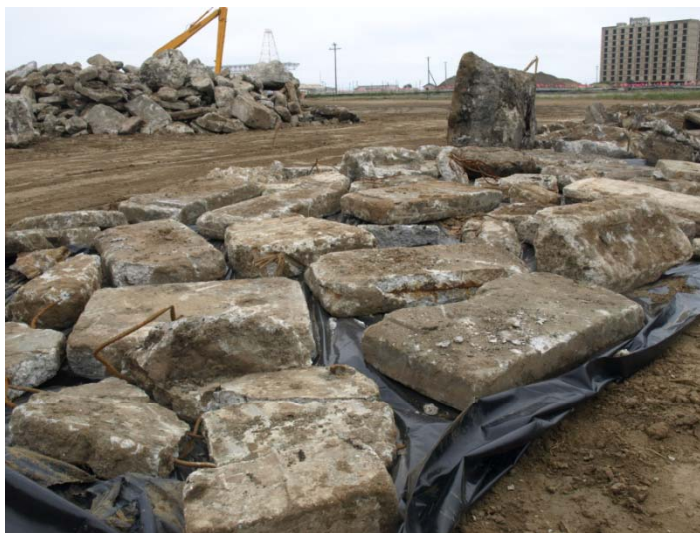
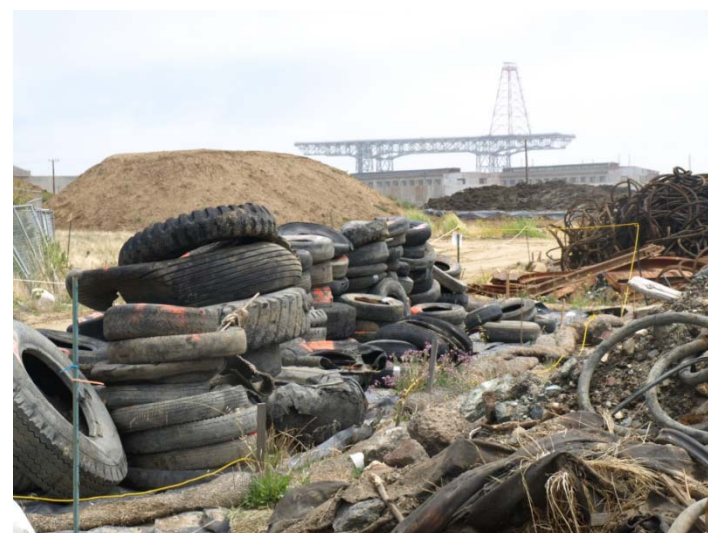
Large Debris Processed and Stockpiled
